NASA/TM-2009-215572
NESC-RP-06-49/06-001-E

International Space Station (ISS) External Television (TV) Camera Shutdown Investigation

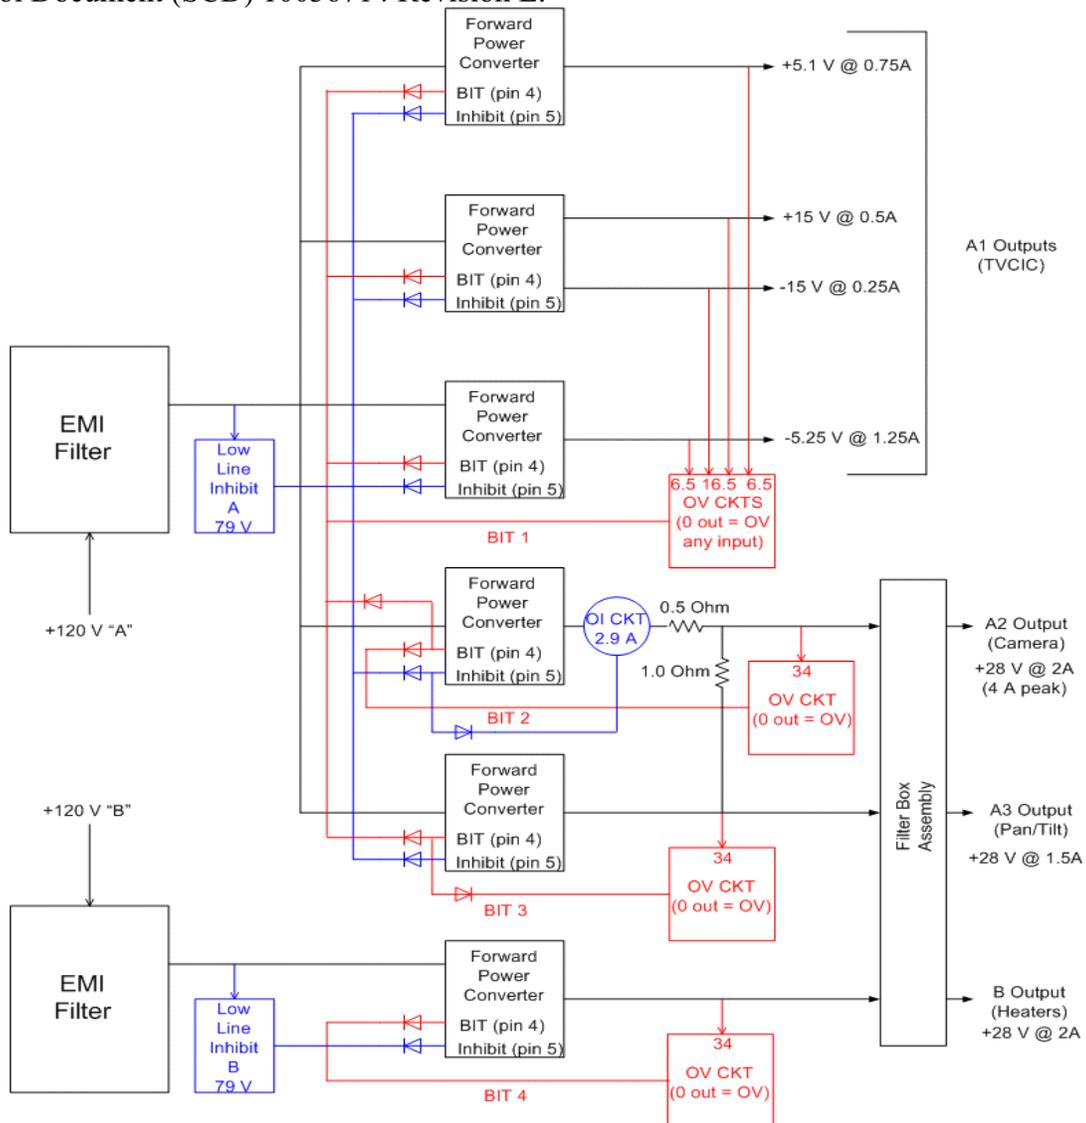
Figure 7.1-6. Type IV (MDI) Power Supply Block Diagram

A block diagram of the Type IV power supply as manufactured by MDI is shown in Figure 7.1-6. This unit is defined by General Electric Aerospace (now L-3 Communications) Source Control Document (SCD) 10036714 Revision L.

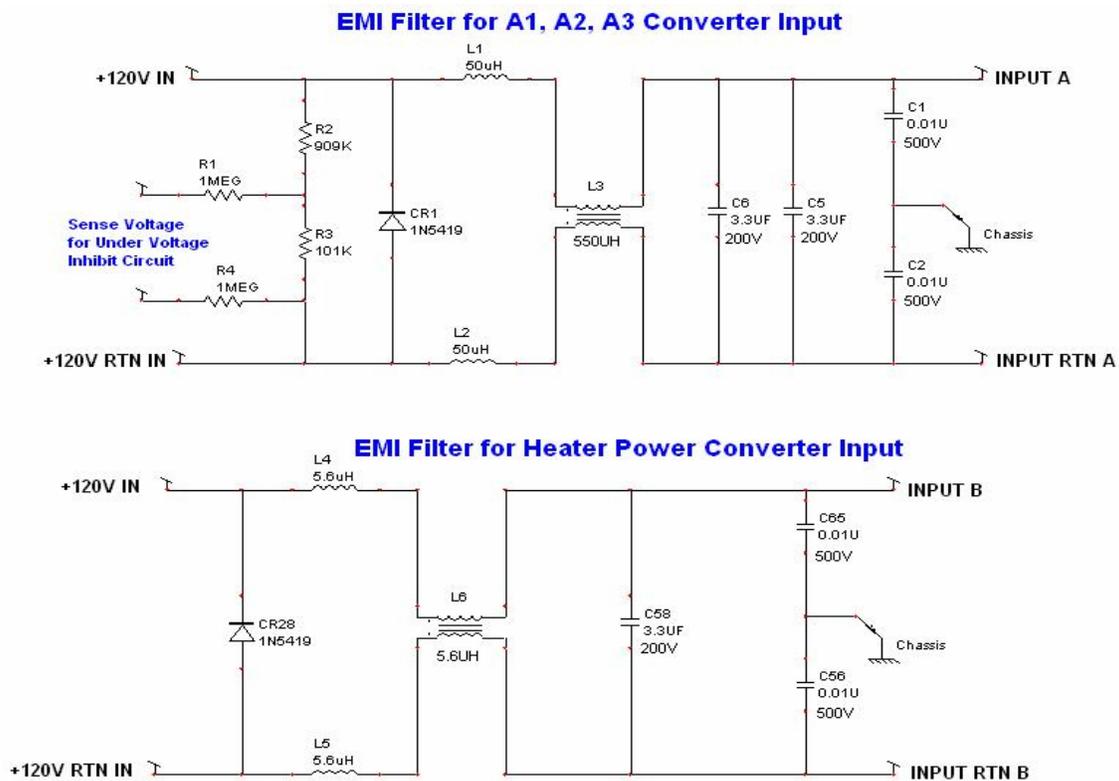
**Figure 7.2-1. Simplified Schematics of EMI Input Filters
(Based on data provided by MDI)
[ref. Schematic Diagram Power Supply, GE Type IV, MDI Drawing 2696-02]**

The MDI Type IV power supply unit has two separate EMI input filters. These filters are built up as a separate assembly and incorporated internal to the Type IV unit.

Figure 7.2-1 illustrates the electrical circuit of the EMI filters internal to the Type IV unit. Note: This schematic was redrawn from schematic information that was fax'ed from MDI (as such there may be some errors in interpretation).

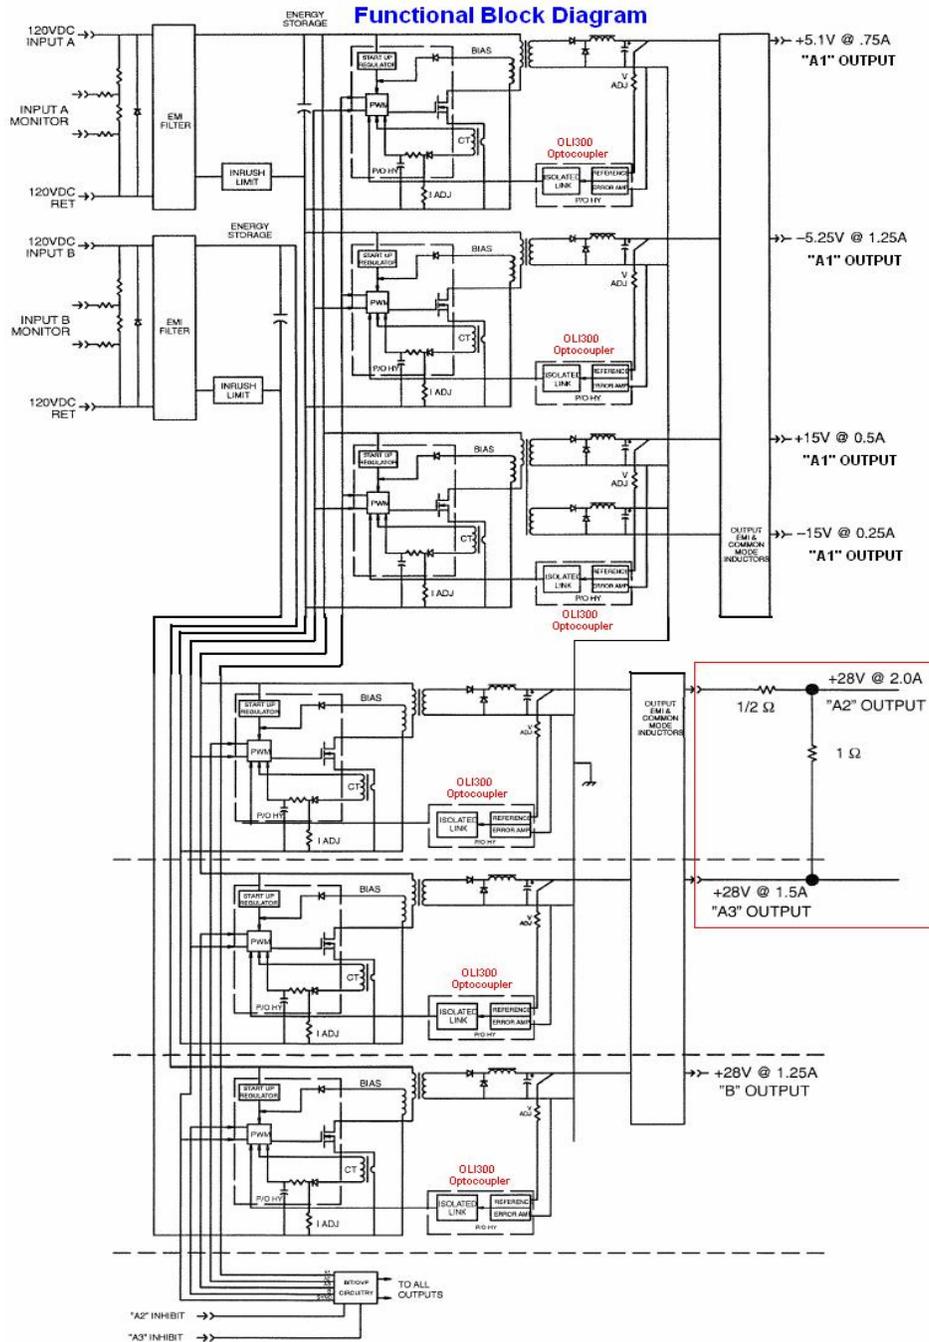
Figure 7.7-1. Functional Block Diagram - Type IV Supply
 [ref. Source Control Drawing, Power Supply, Type IV, GE Aerospace Drawing 10036714]

The SCD that was in effect when the MDI unit was procured includes diagrammatic information of the Type IV power supply summarized in Figure 7.7-1.
